**INTERIM FIELD PROCEDURE FOR BOMB
DAMAGE REPAIR - USING CRUSHED ^{LINE} STONE FOR
CRATER REPAIRS AND SILIKAL® FOR SPALL REPAIRS**

MICHAEL T. McNERNEY
ENGINEERING DIVISION,
RAPID RUNWAY REPAIR SECTION

APRIL 1979

INTERIM REPORT
JUNE 1978 - MARCH 1979

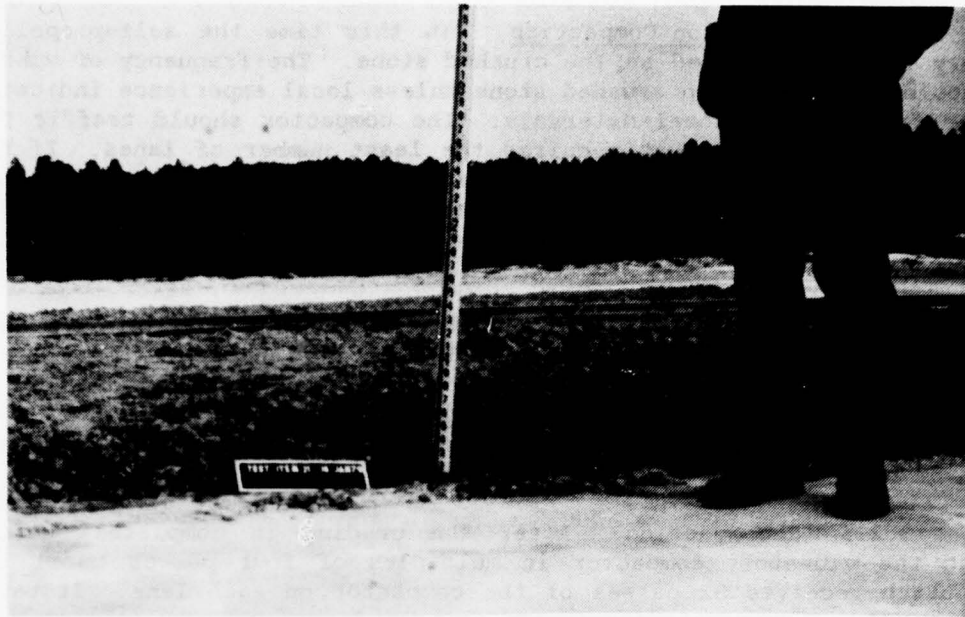
Figure 1
Crater Over-filled with Six Inches of Uncompacted Crushed Stone

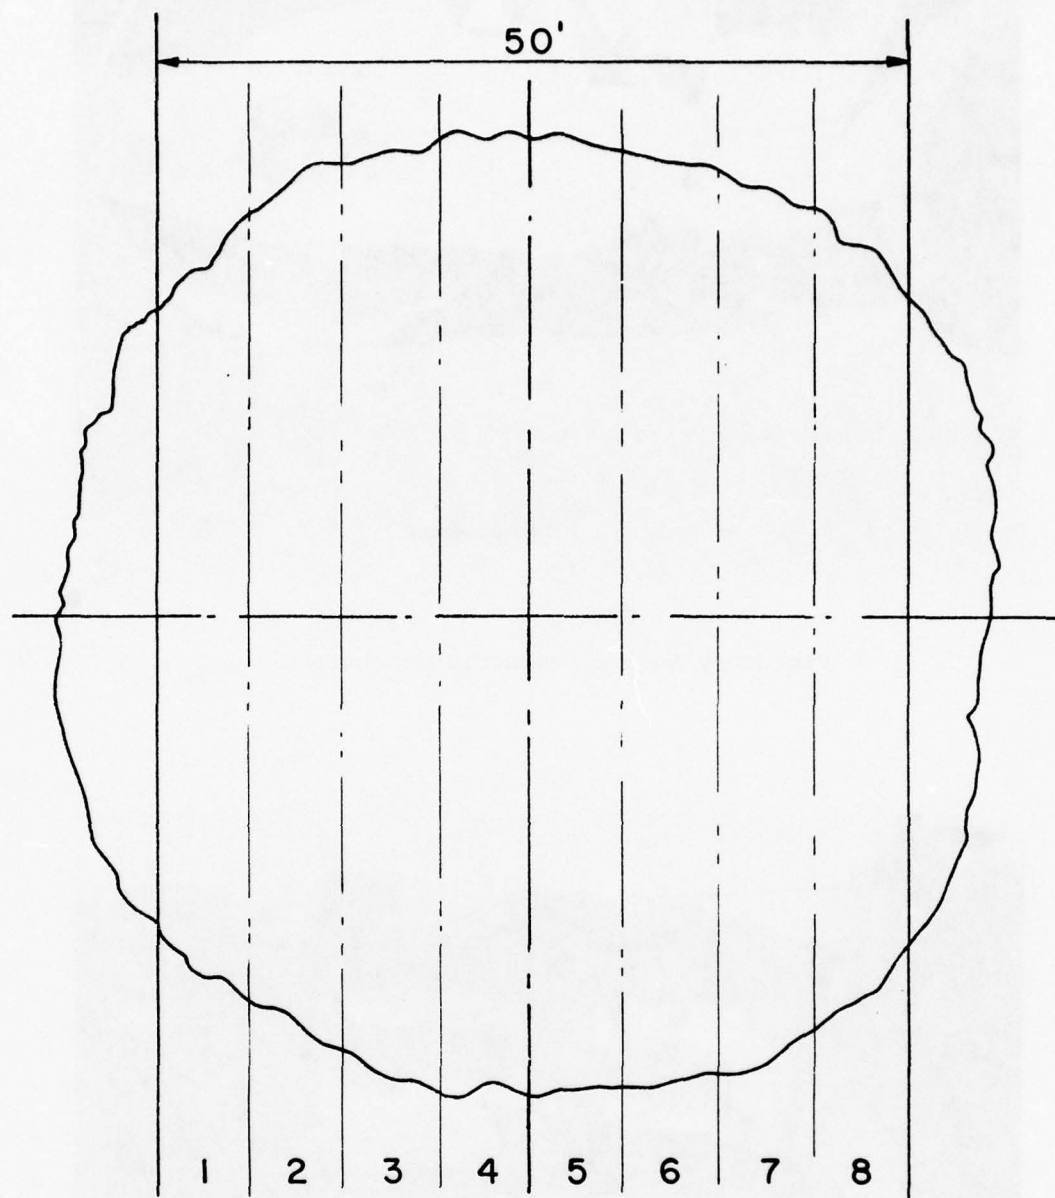
Figure 3. Compacting Lanes for Typical
750-Pound Bomb Crater

3.2.3 Vibration Compaction. At this time the self-propelled vibratory roller is placed on the crushed stone. The frequency of vibration should be 1500 vpm on crushed stone unless local experience indicates a better frequency on local materials. The compactor should traffic the repair in the direction that requires the least number of lanes. If the repair exceeds 50 ft in diameter, compact only the portion within the emergency launch strip using the minimum number of lanes (Figure 3). Compact the repair four passes at a time on each lane, then move to the next lane (Figure 4).

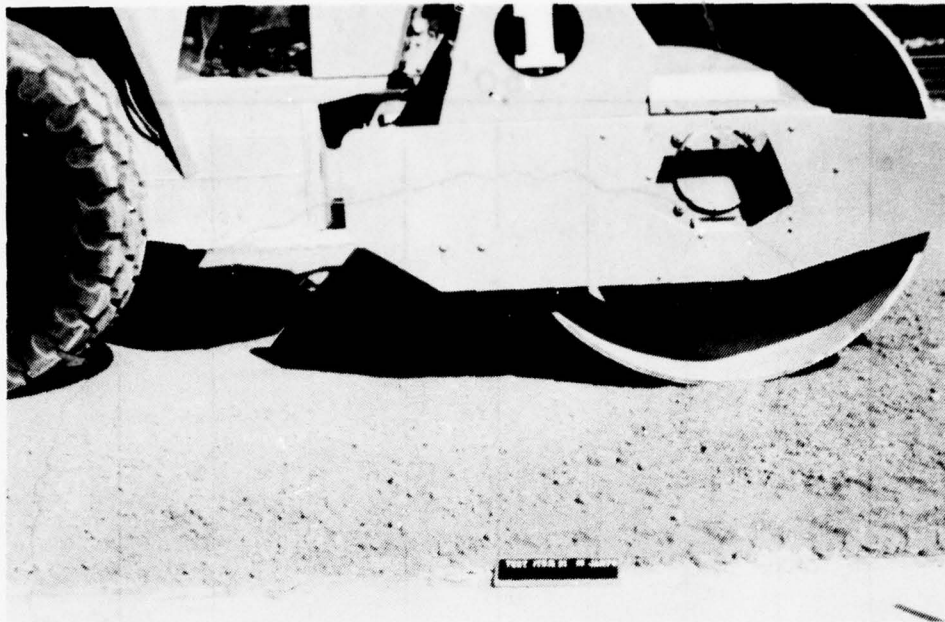
Figure 4
Vibratory Roller Compacting Each Lane

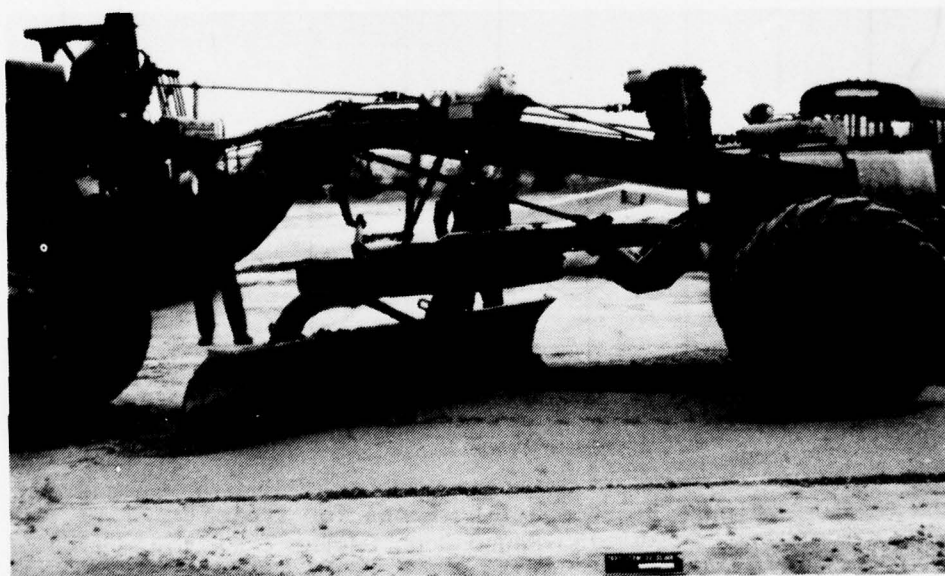
Figure 5
Grader Operator Grades the Patch After Four Coverages of the
Vibratory Roller

3.2.4 Grading. After four passes of the compactor have been applied to each lane the patch should be releveled to approximately one and one-half inches above the concrete. The easiest way to do this is to use an experienced grader operator to grade the patch (Figure 5). An experienced operator can do this in a single pass per lane with only a minimum of hand work with shovels required.

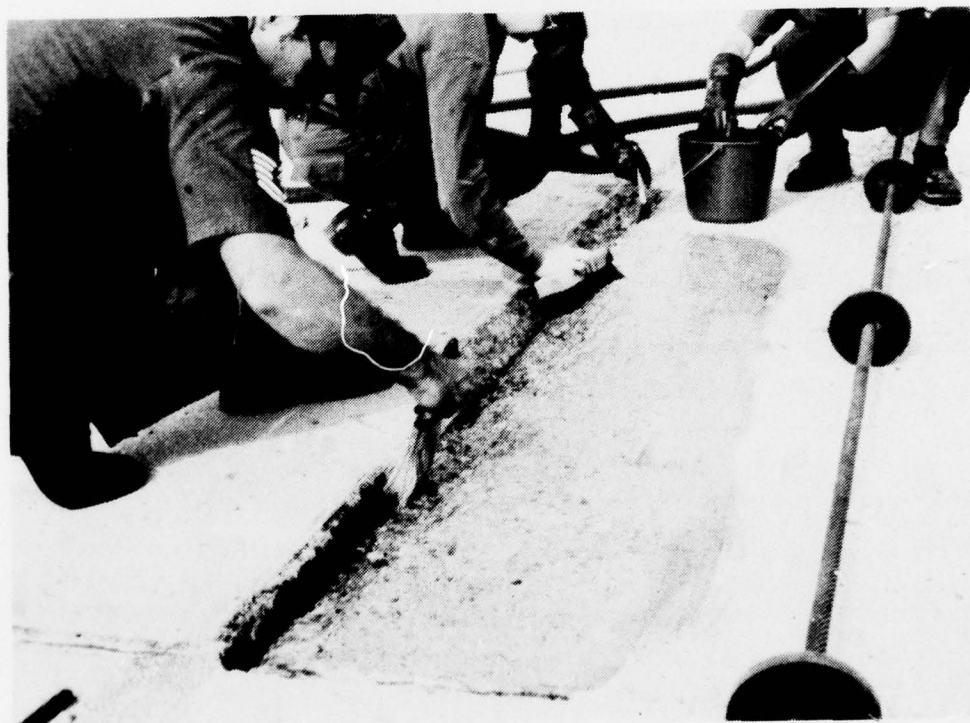
Figure 27
Primer Added to Insure Bond to Concrete to be Overlayed

asphalt was being used as a temporary solution, but was seriously deteriorating (Figure 26). A repair was made using Silikal® R-17 patching material and Silikal® R-7 overlay material. Because this was a permanent repair, two things were done differently from the procedures outlined in Section IV. After the asphalt and unsound concrete were removed, the cleaned concrete surface was primed using Silikal® R41S primer to improve the bond to the concrete (Figure 27). This is not required during emergency repairs, but can be used during routine maintenance repairs. The second change was the use of Silikal® R-7 overlay material for a thin surfacing to protect the existing concrete from further damage.
